ENGINEERING & CONSULTING

888-688-4560

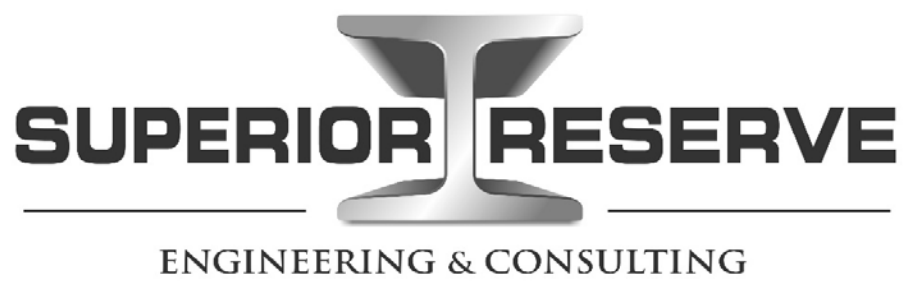
**2020****Hybrid Reserve Expenditures and Funding Plan**

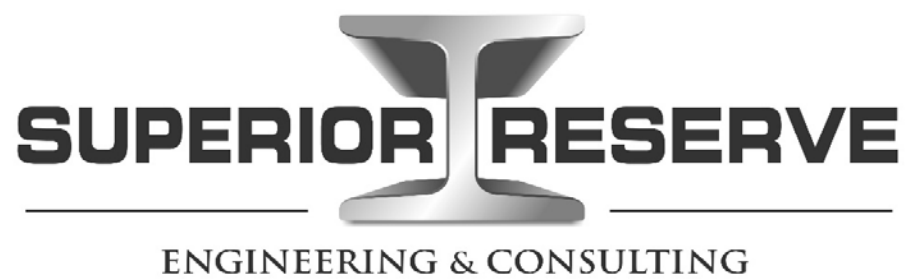
**2021****Hybrid Reserve Expenditures and Funding Plan**

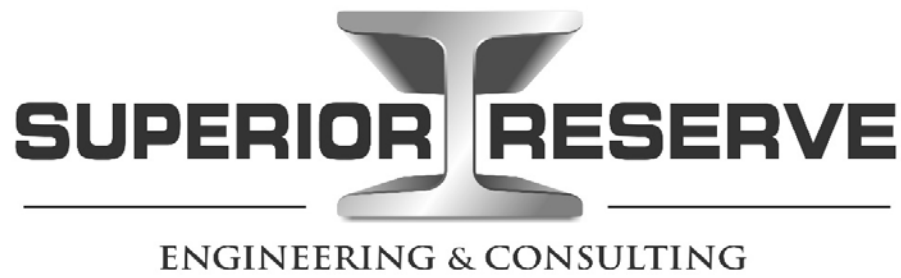
Number of phases	Flexibility	Engineering Data Section	
Deck - Wood	1	deferrable	2.182	(\$38,249)
Painting - Deck and Gazebo	1	firm	2.432	(\$3,567)
Painting - Garage (1)	1	discretionary	5.571	(\$4,919)
Roof - Garage	1	firm	5.577	(\$25,827)
Pavement Replacement - Parking Areas (1)	1	deferrable	6.661	(\$177,102)
Pool and Deck Furniture	1	deferrable	8.401	(\$24,597)
Total expenditures:				(\$274,262)
			Ending reserve balance:	<u>\$95,209</u>

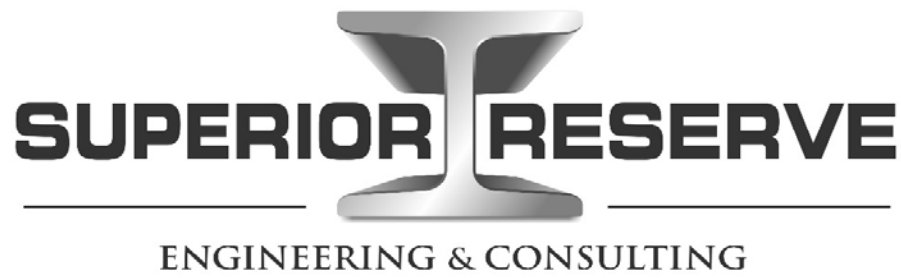
Number of phases	Flexibility	Engineering Data Section	
Landscape (5% every 5 years)	1	discretionary	6.541	(\$4,153)
Pavement Crack Repair and Patch	1	firm	6.641	(\$3,599)
Pavement Seal Coat and Striping (1)	1	discretionary	6.641	(\$5,952)
Total expenditures:				(\$13,704)
			Ending reserve balance:	<u>\$180,766</u>

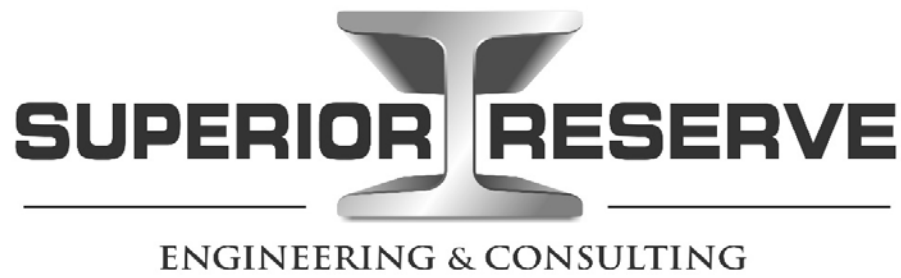
Number of phases	Flexibility	Engineering Data Section	
Painting - Wood Siding and Balconies	1	firm	2.431	(\$43,623)
Laundry Washers and Dryers	1	deferrable	4.521	(\$8,101)
Concrete Patios (1 of 14 every 5 years)	1	deferrable	6.161	(\$3,739)
Concrete Sidewalks, Drive and Stoops (5% every 5 years)	1	deferrable	6.181	(\$4,051)
Pavement Crack Repair and Patch	1	firm	6.641	(\$4,051)
Pavement Seal Coat and Striping (1)	1	discretionary	6.641	(\$6,699)
Total expenditures:				(\$70,264)
			Ending reserve balance:	\$379,889

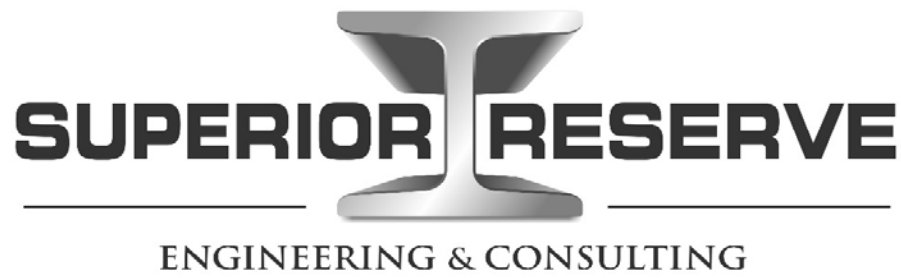
Number of phases	Flexibility	Engineering Data Section	
Pavement Crack Repair and Patch	1	firm	6.641	(\$4,559)
Pavement Seal Coat and Striping (1)	1	discretionary	6.641	(\$7,540)
Pool Mechanical Equipment - Pump (1)	1	deferrable	8.501	(\$3,332)
Pool Mechanical Equipment - Filter (1)	1	deferrable	8.501	(\$2,806)
Total expenditures:				(\$18,236)
			Ending reserve balance:	<u>\$645,017</u>

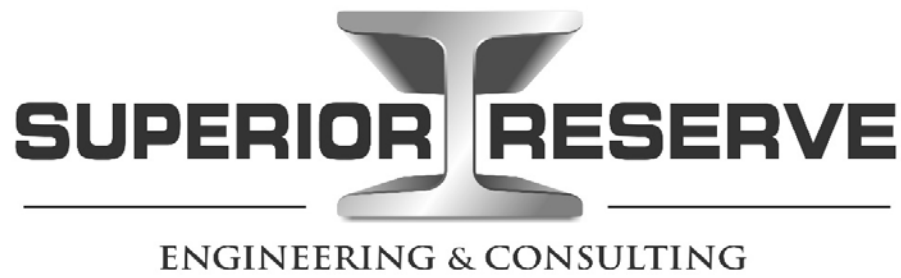
Ending reserve balance: \$658,444

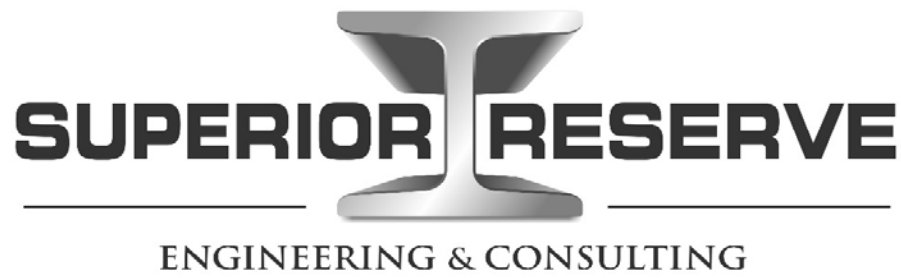
Number of phases	Flexibility	Engineering Data Section	
Lighting - Stairs (1)	1	deferrable	3.421	(\$15,993)
Painting - Garage (1)	1	discretionary	5.571	(\$8,885)
Pavement Replacement - Parking Areas (1)	1	deferrable	6.661	(\$319,866)
Pavers	1	deferrable	6.721	(\$59,086)
Pool and Deck Furniture	1	deferrable	8.401	(\$44,426)
Total expenditures:				(\$448,256)
			Ending reserve balance:	<u>\$531,491</u>

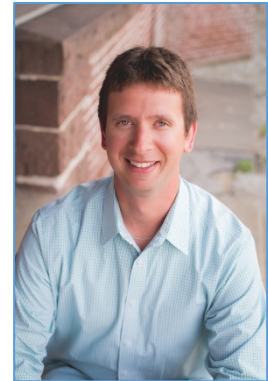
Justin J. Maier is a partner and co-founder of Superior Reserve Engineering and Consulting. Justin J. Maier provides *expert* reserve and transition studies, and critical property reviews. Properties that have benefited from his experience include townhome associations, condominium associations, planned unit developments, marinas, resorts, hotels, churches and country clubs. These properties vary from complex high rise buildings to vintage buildings of historical significance. He has provided these services to *more than 1,600* properties throughout the United States and worldwide.

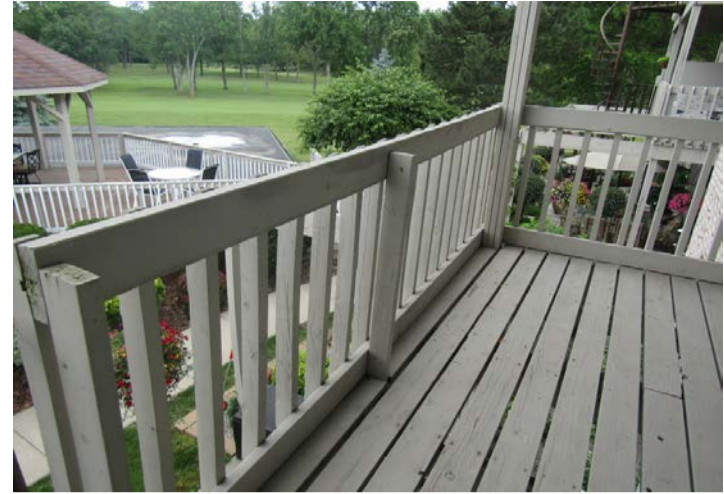
balconies with wood frames, wood deck boards and wood railings

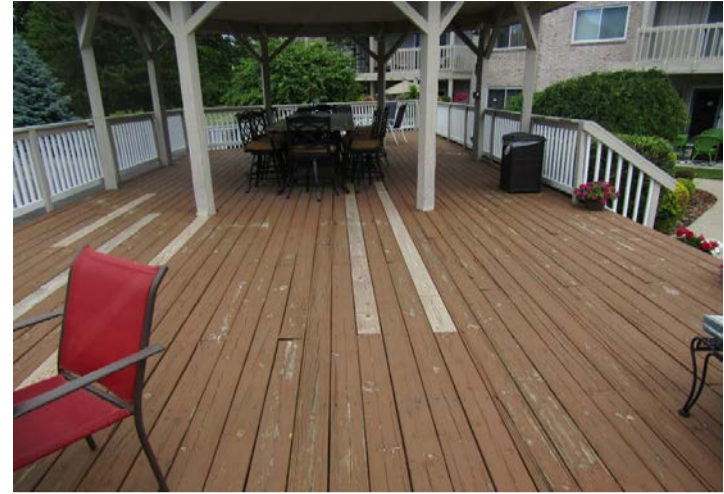
deck with wood frames, wood deck boards and wood railings

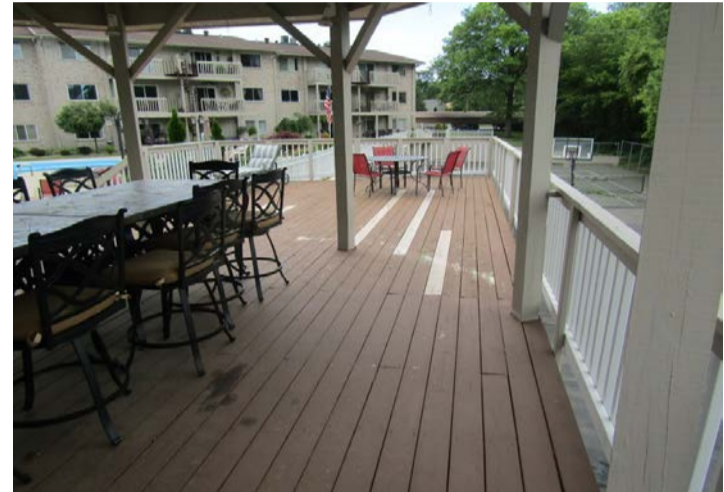
replaced deck boards

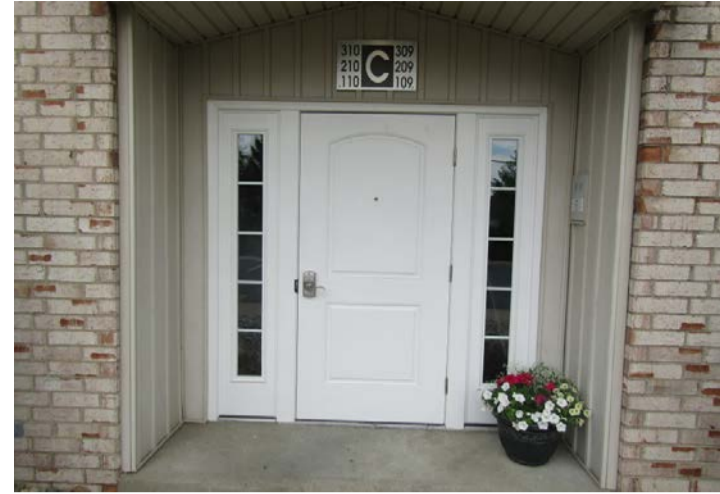
wood common entrance door with sidelights

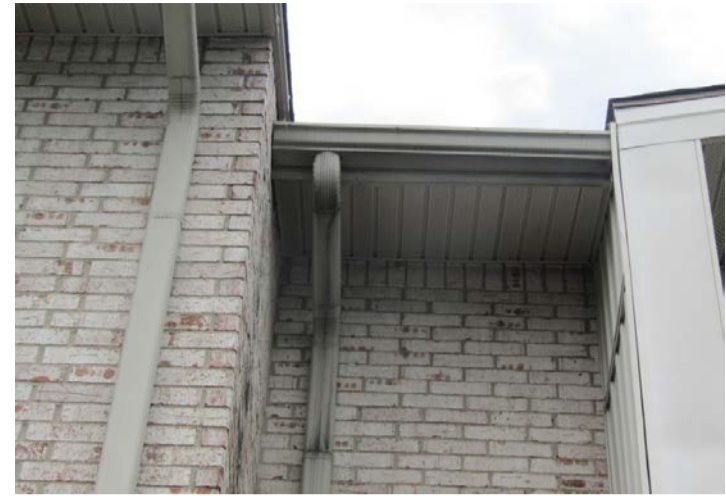
aluminum gutters and downspouts

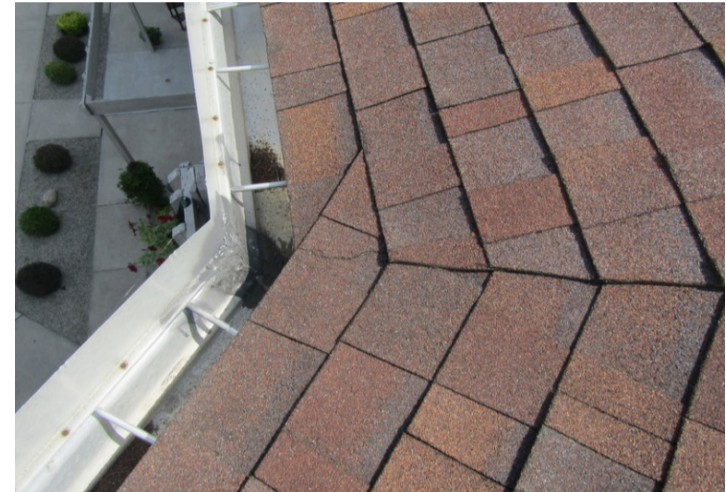
repaired gutter leak

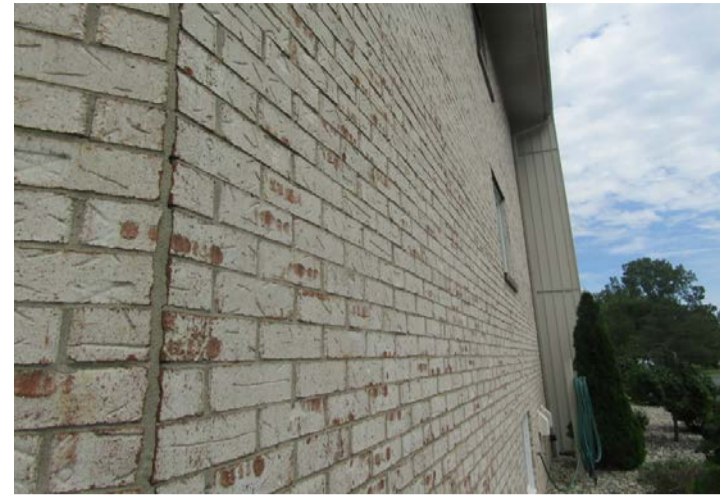
masonry facade with 3 by 10 inch masonry units and running bond pattern

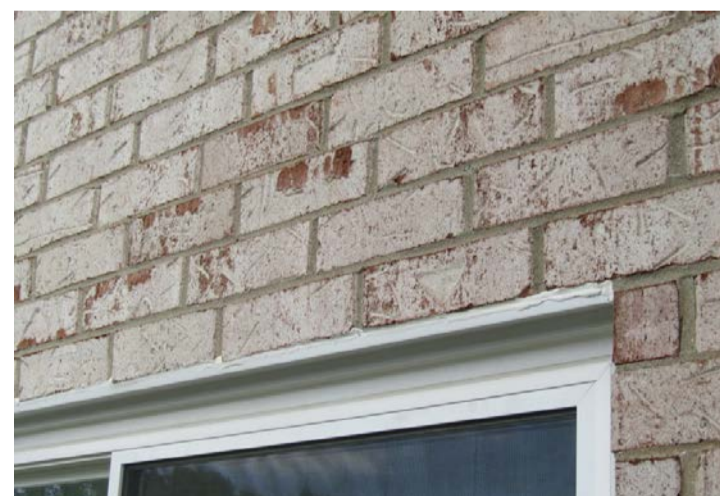
cladding and caulk inappropriately installed over lintel

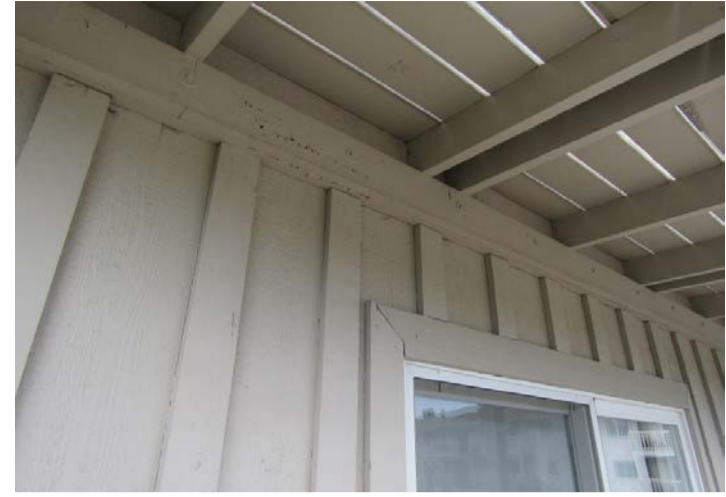
Components to replace: wood siding (5%)
caulk at windows and doors (50%)

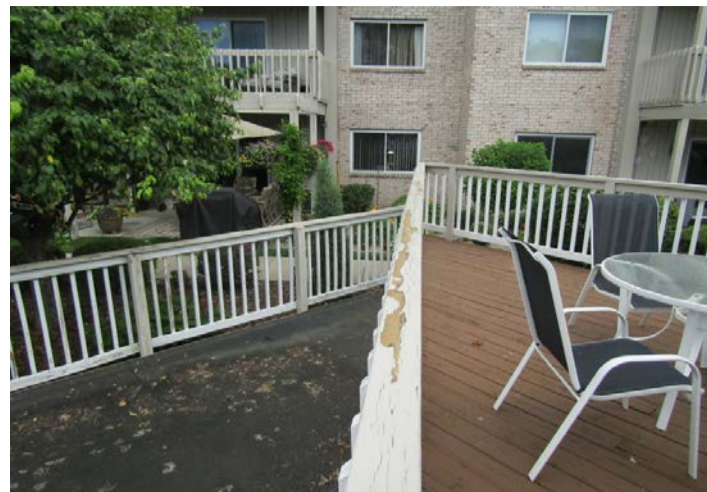
peeling paint at railing

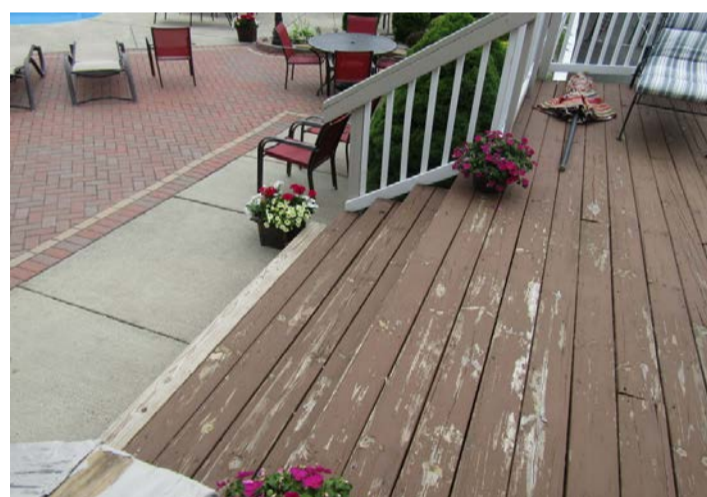
worn paint at deck and steps

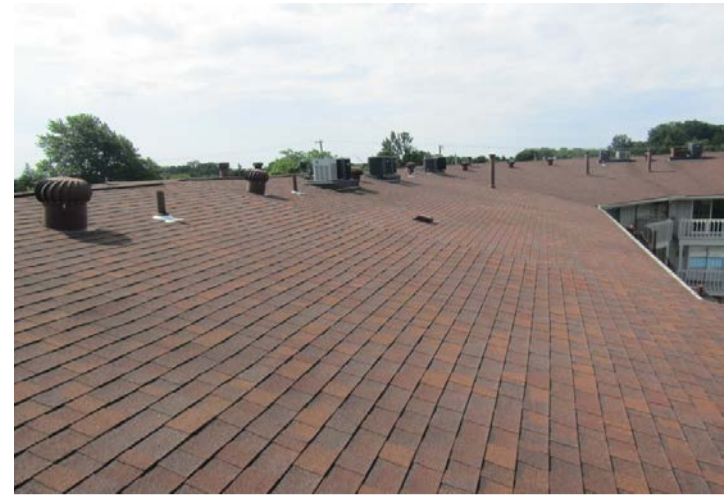
roof with asphalt shingles

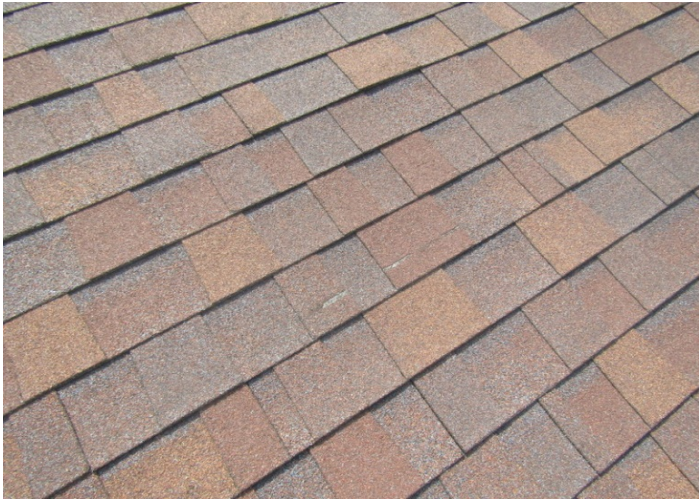
damaged shingles and fiberglass exposure

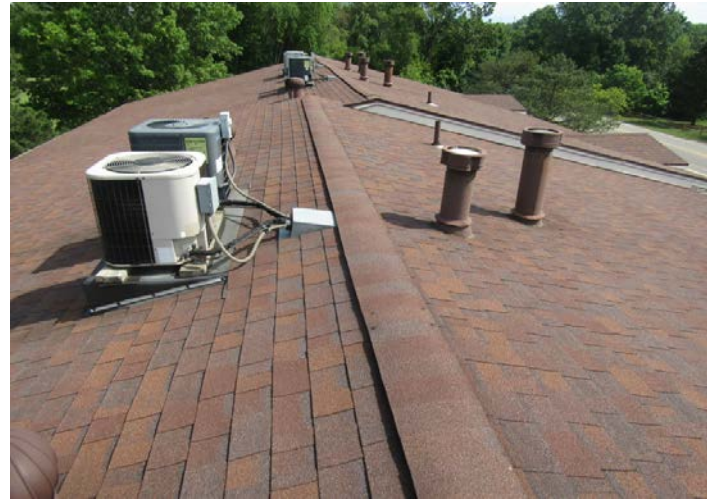
ridge vent without wind baffles

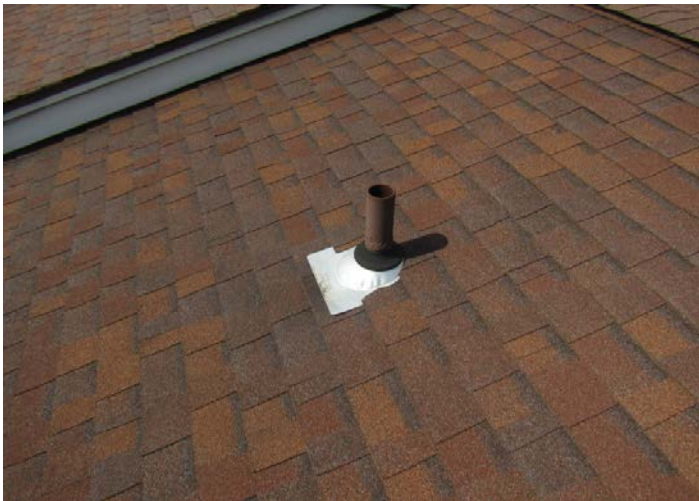
unsecured flashing - semiannual inspections to address these conditions

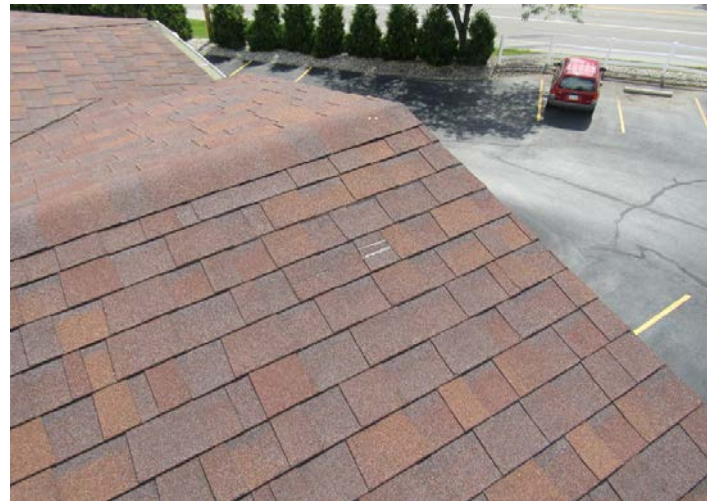
damaged shingles and fiberglass exposure

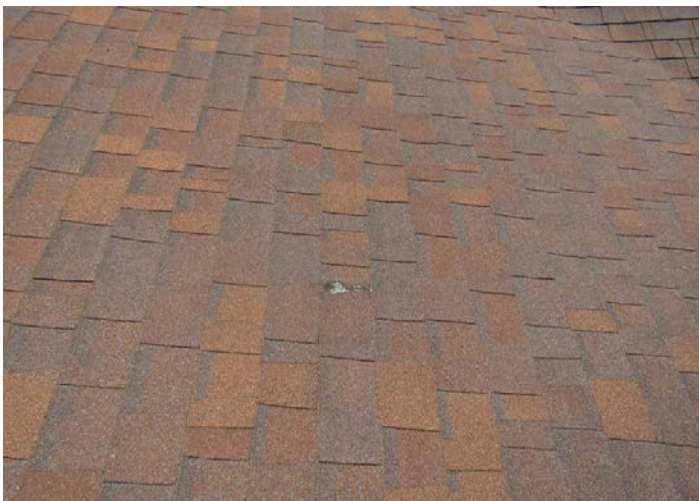
damaged shingles and fiberglass exposure

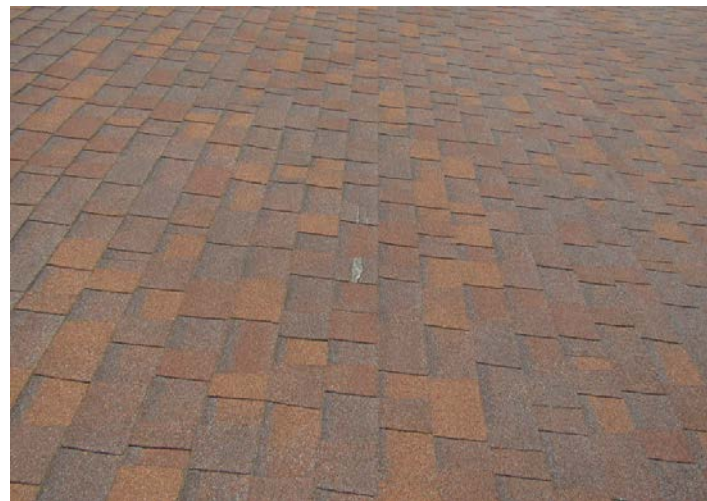
damaged shingles and fiberglass exposure

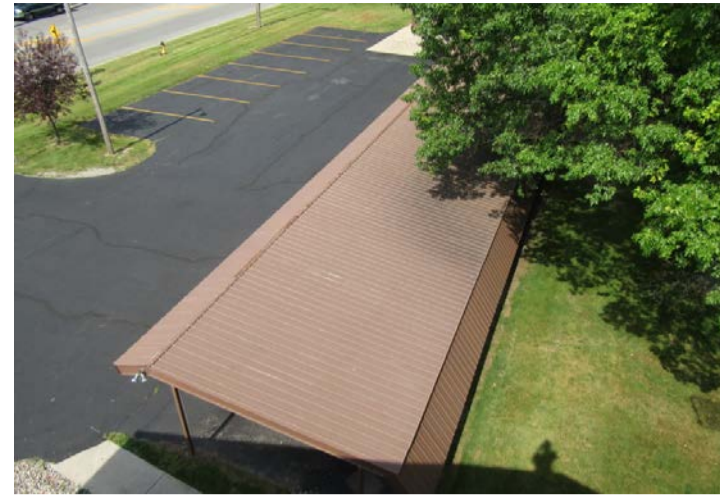
roof with metal panels

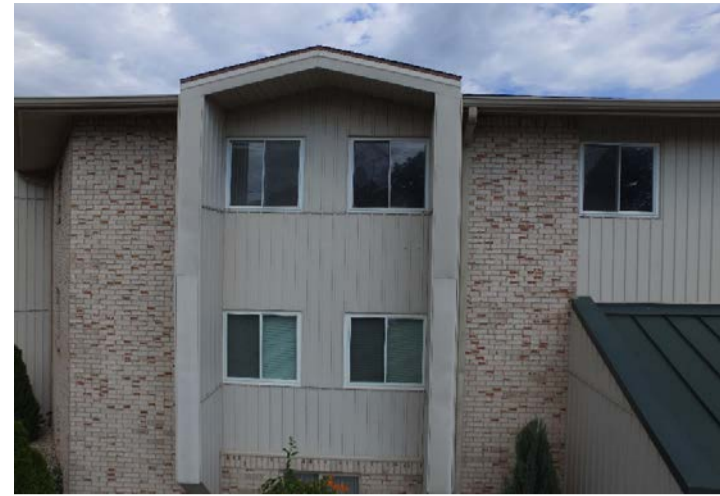
vinyl siding with ribbed profile

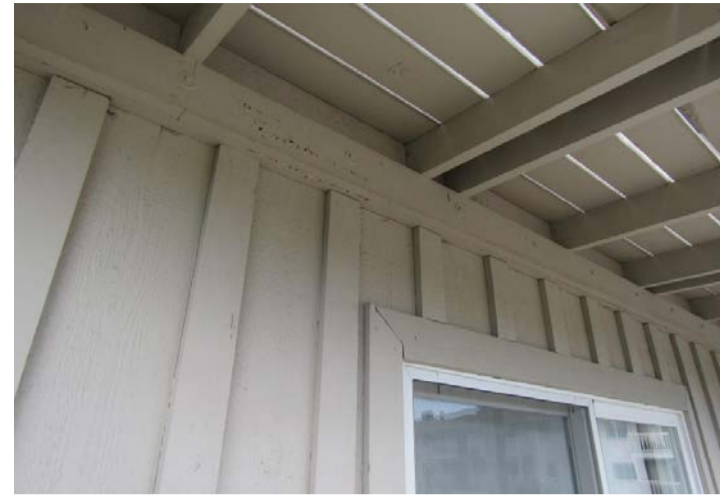
wood siding with board and batten profile

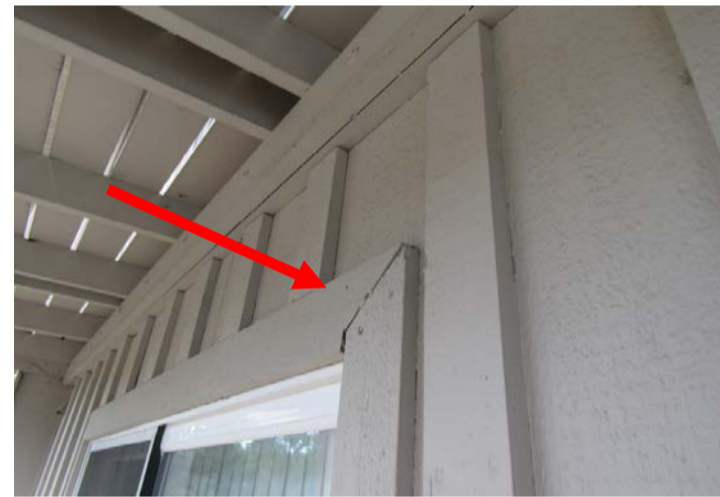
wood siding at garage

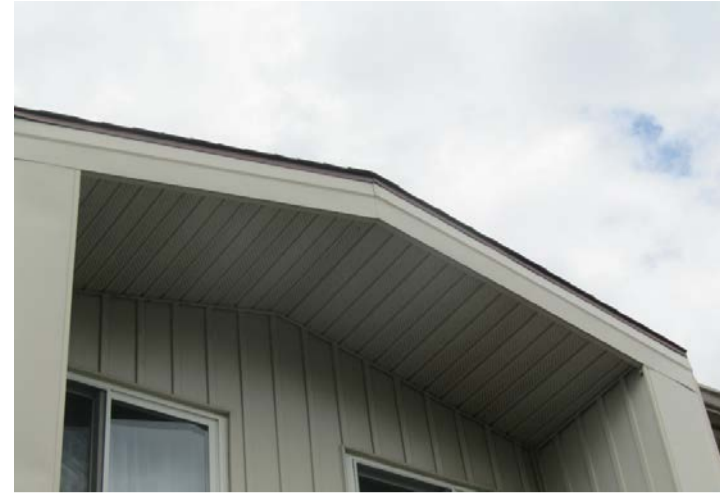
aluminum soffits and fascia

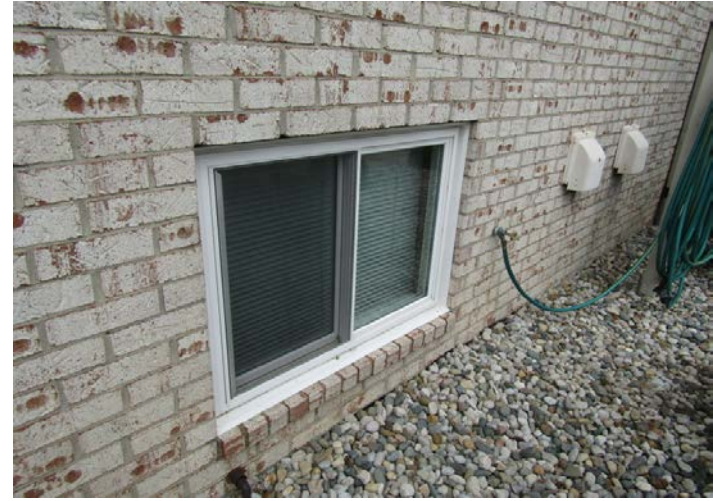
vinyl frame, dual pane glass, sliding window

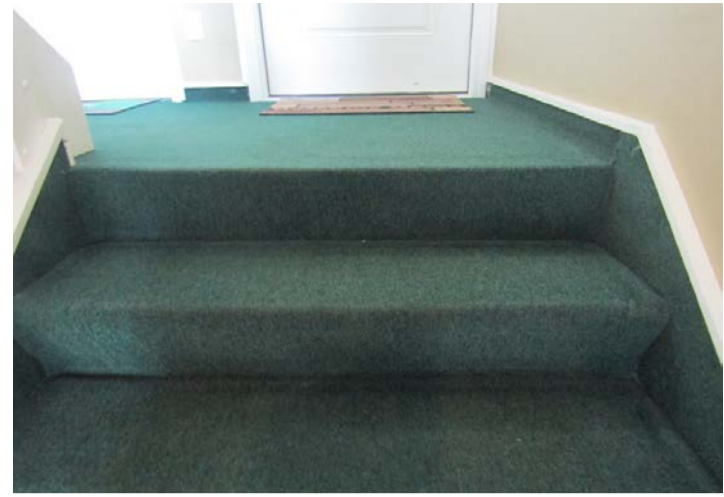
broadloom loop pile carpet typical of the stairs

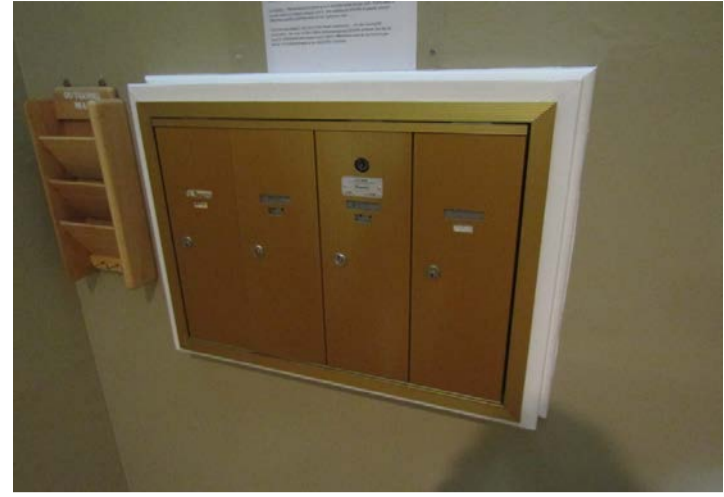
Locations:	lobbies
Manufacturer:	<i>Bommer</i>
Size:	16 inches x 5 inches
Overall condition:	good to fair
Specific condition:	minor wear
Quantity (each):	40
Cost (\$/box):	\$100
Current total cost:	\$4,000
Operating expenses:	lock replacement, refinishing

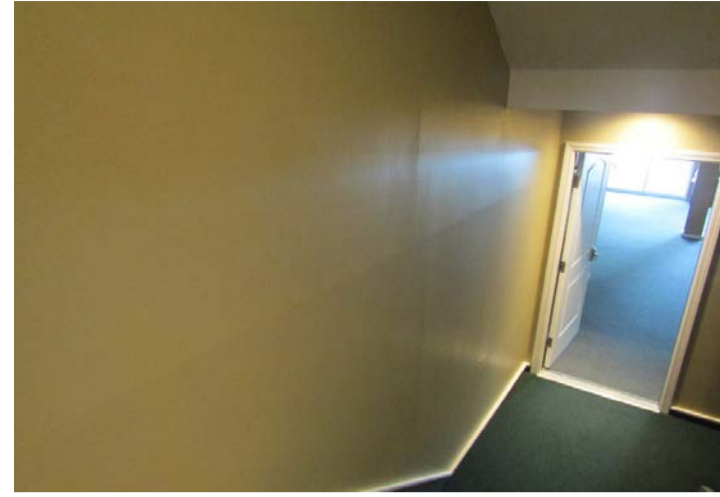
Number of stairwells:	7
Overall condition:	good
Specific condition:	no visible deterioration
Average cost per stairwell:	\$3,500
Current total cost:	\$24,500
Cost per home:	\$613
Cost also includes:	removing wallpaper
Operating expenses:	interim paint touch ups and wall repairs
Surfaces to paint:	walls ceilings floors railings doors

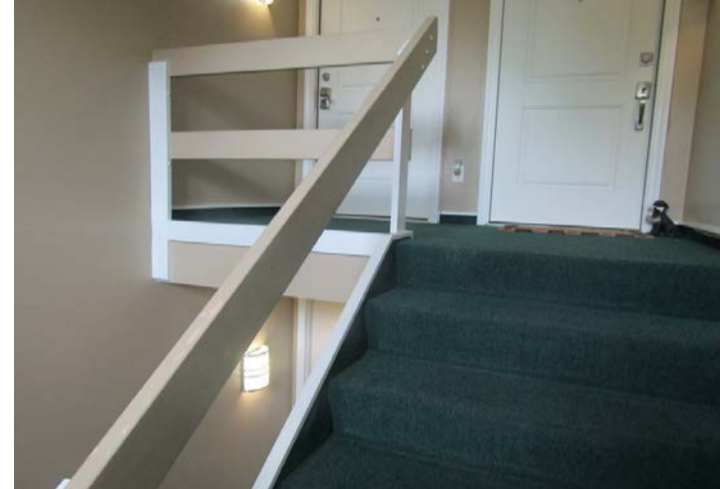
missing balusters at railing

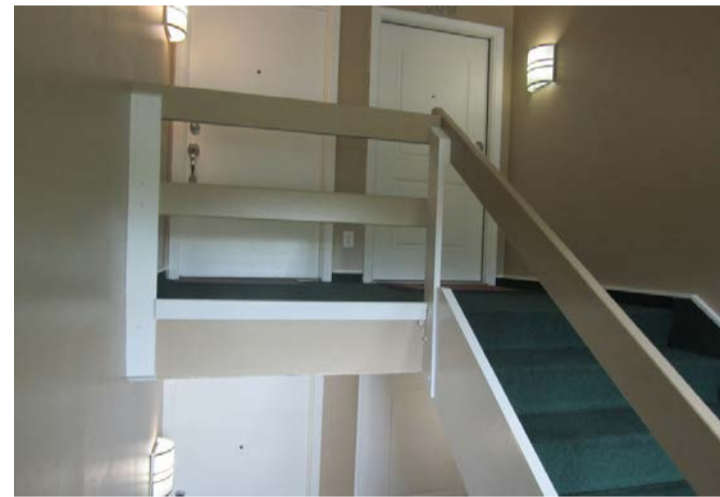
missing balusters at railing

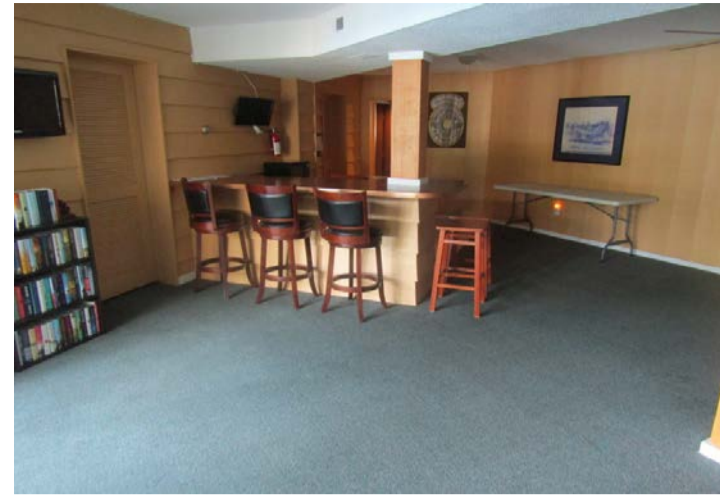
Green ideas: Install motion sensors on the community, storage and mechanical room light switches to minimize fixture operation. Motion sensing light switches are inexpensive: <http://www.homedepot.com/b/Electrical-Dimmers-Switches-Outlets-Motion-Sensors/N-5yc1vZc32r/Ntk-Extended/Ntt-light+switch?Ntx=mode+matchpartialmax&NCNI-5>.

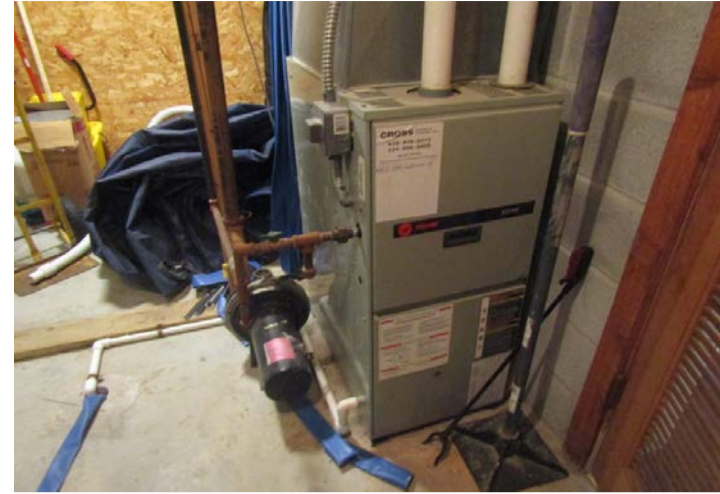
Manufacturer:	<i>Trane</i>
Furnaces:	1
Locations served:	community room
Heating source:	gas-fired
Heating capacity in MBH (note 1):	80
Efficiency:	90%
Operational condition:	satisfactory
Physical condition:	no visible deterioration
Current total cost:	\$2,700
Cost per home:	\$68
Operating expenses:	interim repairs and component replacements

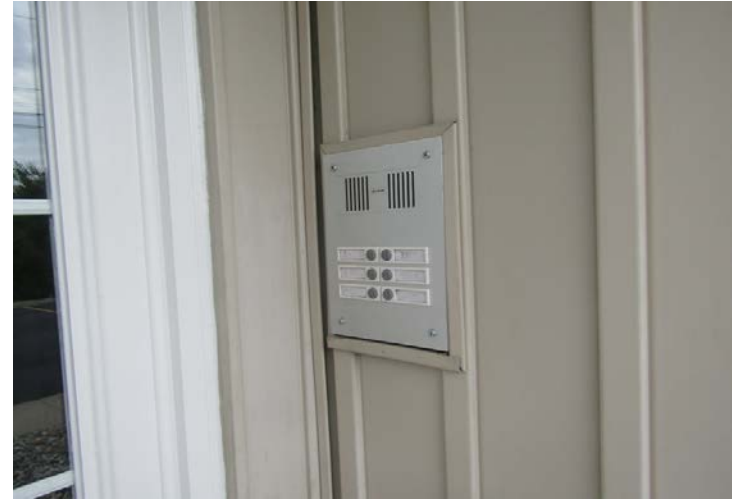
Aiphone intercom system panel

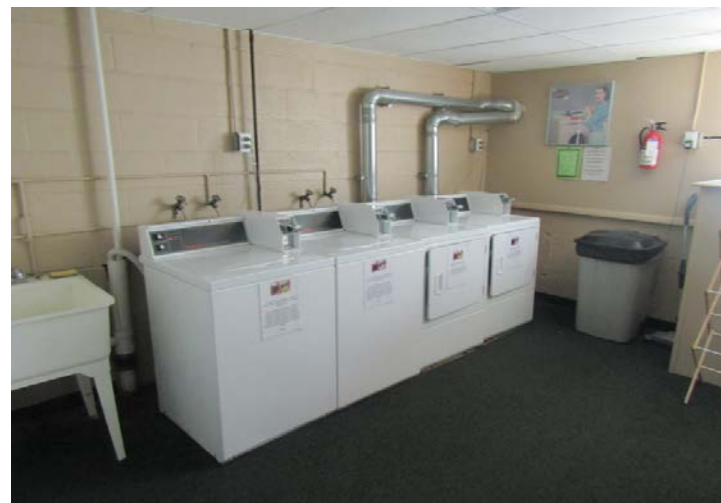
Operating expenses: interim replacement of belts and other components

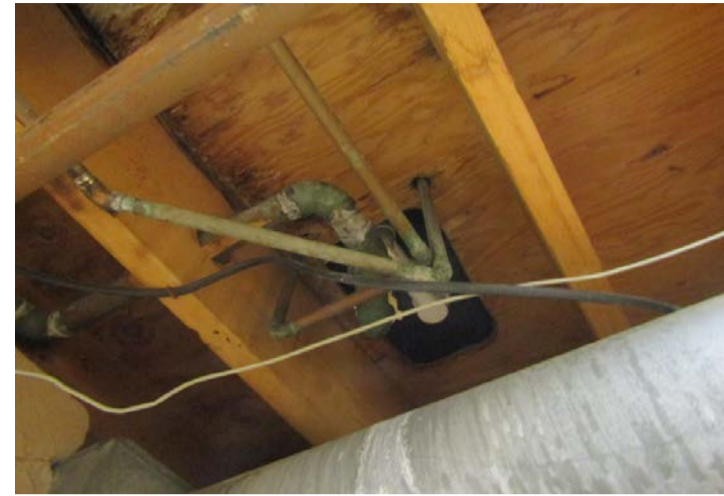
Engineering solutions: With the exception of isolated locations, the pipes are not visible. Even if these pipes were visible, the interior condition of the pipes (which is not visible) determines their remaining useful life. Therefore, we determine the condition and anticipated replacement times of the pipes based on interviews with individuals at the property, the age of the building, and our expertise with many other properties of similar age and plumbing systems.

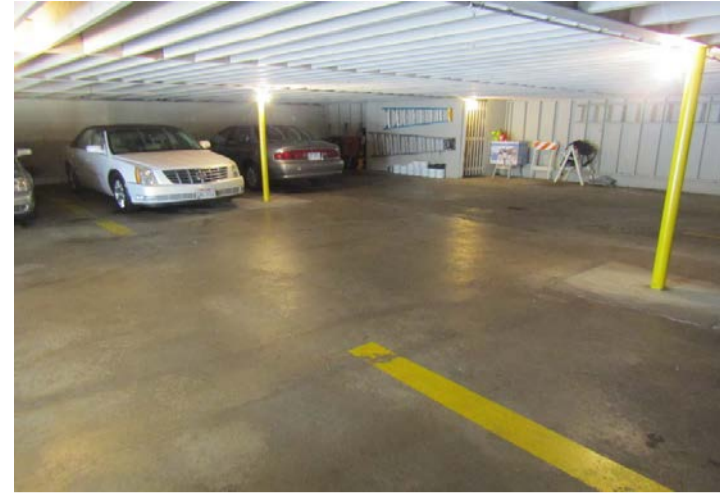
Floor type:	on-grade concrete
Overall condition:	fair
Specific condition:	cracks, worn concrete and wall leaks
Floor area (square feet):	3,000
Current total cost (note 1):	\$7,000
Cost per home:	\$175
Operating expenses:	sealer application (only if desired), interim repairs, cleaning
Anticipated expenses:	concrete crack repairs replace on-grade concrete (2%) epoxy injection of wall leaks floor drain replacement drain pipe replacement (20%) stripe parking areas

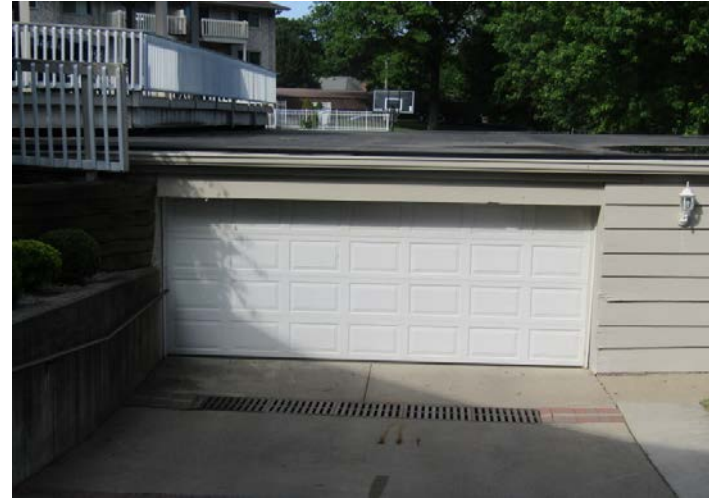
Doors (each):	1
Door material:	metal
Operator manufacturer:	<i>LiftMaster</i>
Operational condition:	satisfactory
Physical condition:	no visible deterioration
Current total cost:	\$4,500
Cost per home:	\$113
Operating expenses:	interim operator and panel replacements

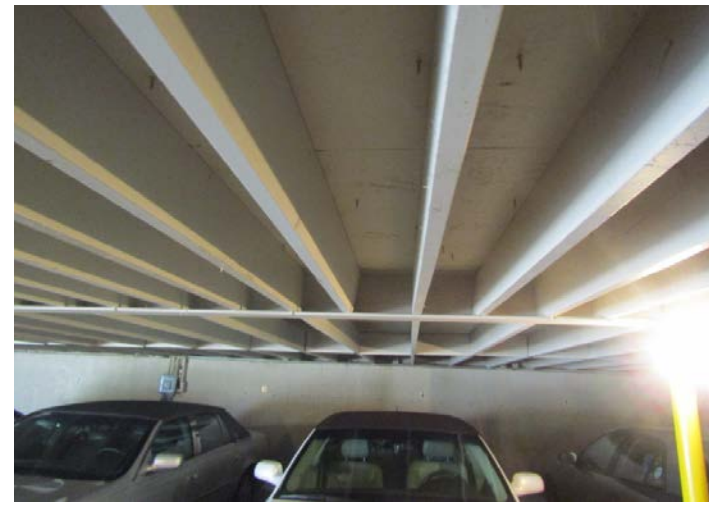
Painted surfaces in garage

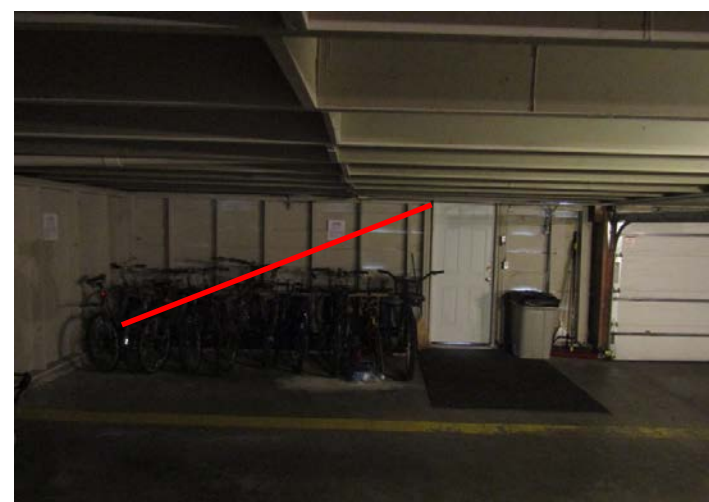
Missing bracing and leaning wall evident

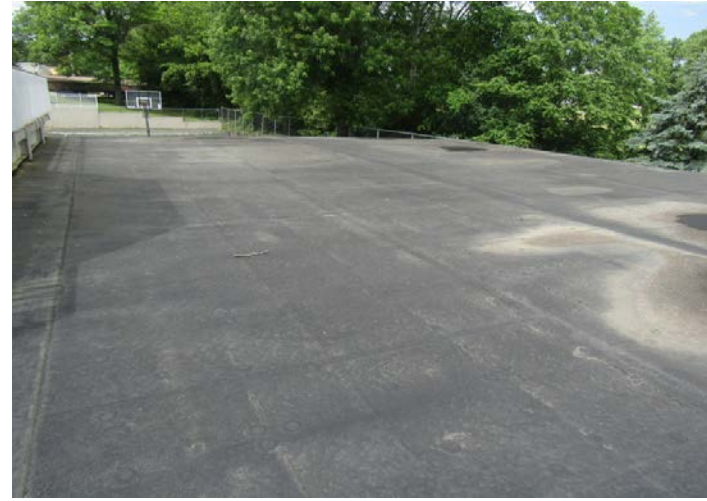
Material:	EPDM
Scheduled inspections:	recommended semiannually
Overall condition:	fair
Specific condition:	standing water and missing drain screen
Leaks:	a history of leaks but none are active
Quantity in squares(note 1):	30
Cost (\$/square):	\$700
Current total cost:	\$21,000
Operating expenses:	semiannual inspections and any necessary repairs
Anticipated expenses:	<p>remove existing roofing (note 2)</p> <p>replace roof deck insulation (1.5")</p> <p>replace flashing</p> <p>45 mils sheet EPDM roofing</p> <p>replace gutters and downspouts (70 l.f.)</p>
Coordinate with:	deck

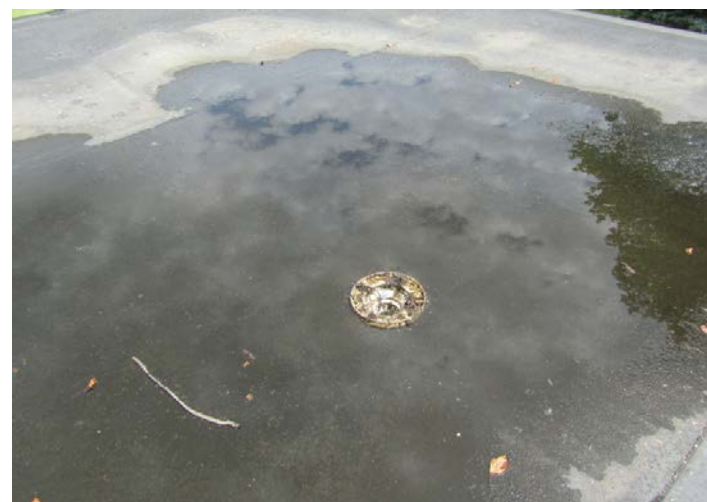
missing drain screen

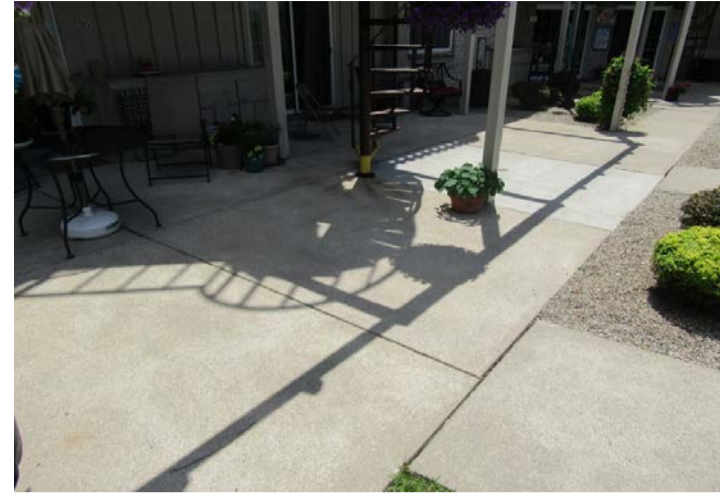
Material:	concrete
Overall condition:	good to fair
Specific condition:	replaced concrete and minor cracks
Locations:	rear of building
Quantity (each):	14
Area each (square feet):	210
Cost (\$/each):	\$2,400
Current total cost (note 1):	\$33,600
Assumptions:	4-inch thick, 3,000 psi replacement concrete with 6x6 - W1.4xW1.4 steel reinforcing mesh
Operating expenses:	interim replacements of deteriorated slabs, slab jacking
Coordinate with:	concrete sidewalks, drive and stoops

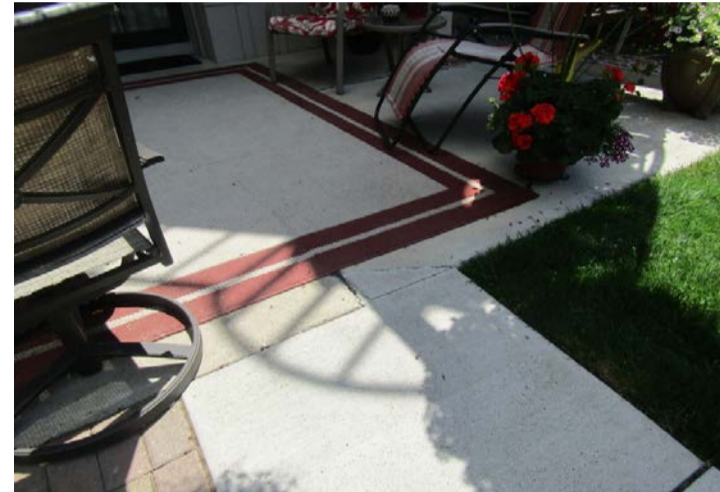
minor crack - no action necessary

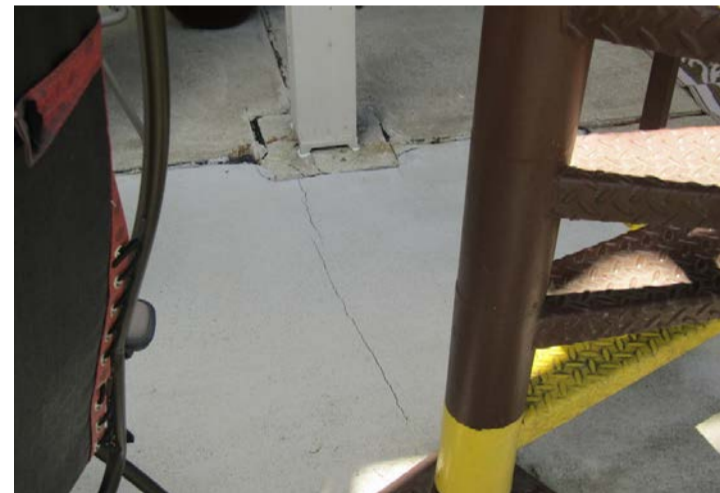
minor crack - no action necessary

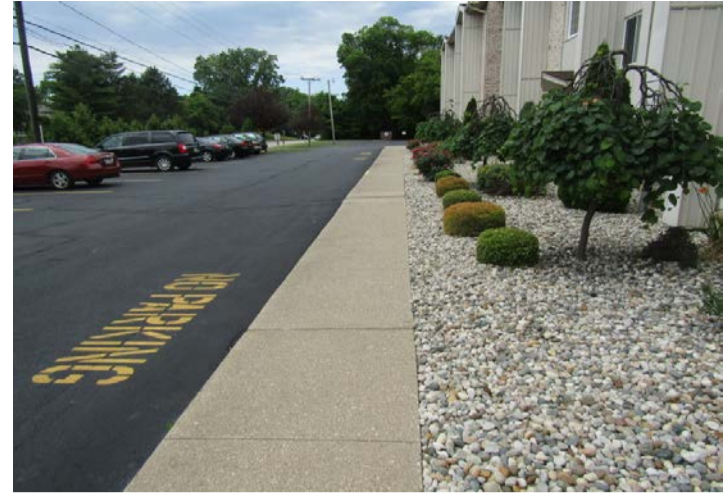
Material:	concrete
Overall condition:	good
Specific condition:	no visible deterioration
Locations:	throughout property
Length (linear feet):	1,000
Quantity (square feet):	6,000
Per home (square feet):	140
Cost (\$/square foot):	\$8.70
Current total cost (note 1):	\$52,000
Assumptions:	4-inch thick, 3,000 psi replacement concrete with 6x6 - W1.4xW1.4 steel reinforcing mesh
Operating expenses:	marking of trip hazards, interim replacements of deteriorated sections, slab jacking (pumping grout under sections to lift them)
Coordinate with:	concrete patios

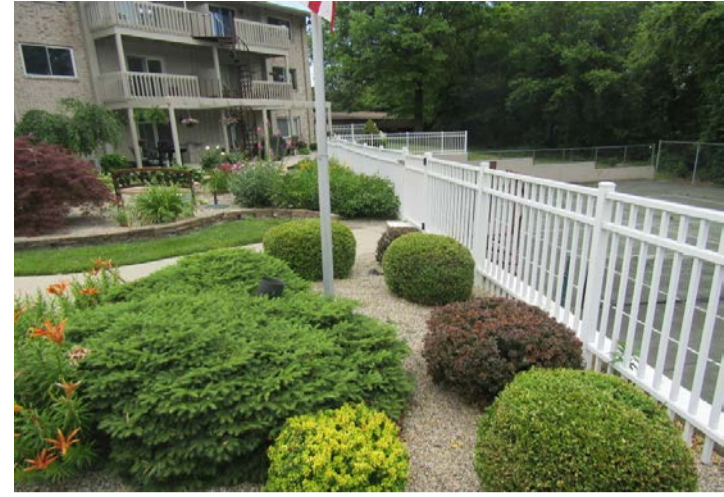
vertical picket metal fence atop tennis court

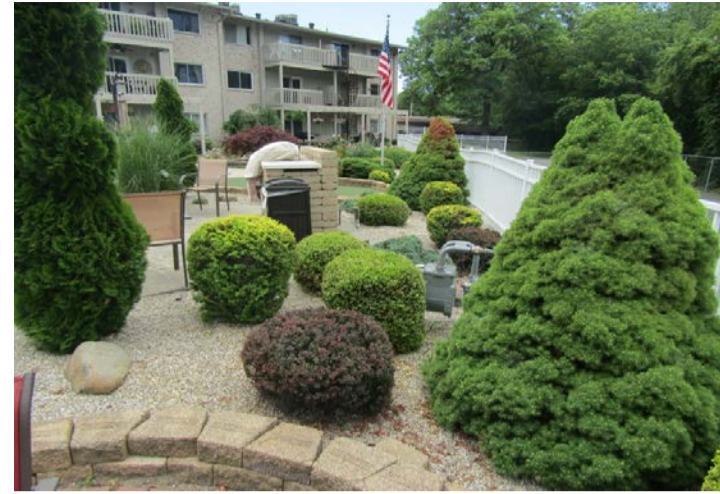
Location served:	entire site
Landscaped acreage:	1.1
Estimated cost (note 1):	\$60,000
Cost per home:	\$1,500
Operating expenses:	mowing, trimming, flowers, sod, stones, etc.
Assumptions:	We base our tree replacement cost on removal of the existing tree and replacement with a balled and burlapped tree, 8'-10' in height, 1" caliper.
Components:	trees bushes repairs to catch basins in landscape areas putting green retaining walls (excluding tennis court)

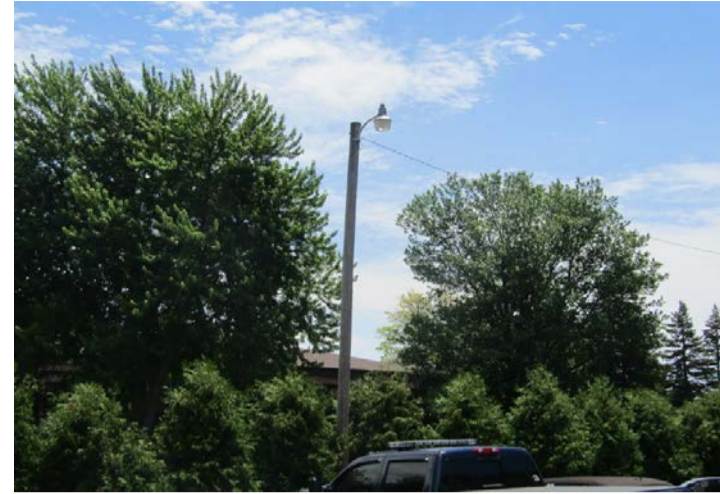
wood light pole with metal light fixture

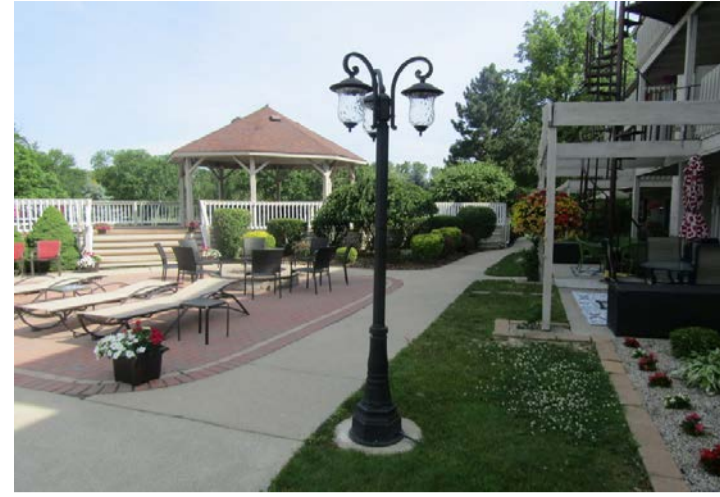
metal light pole with metal light fixture

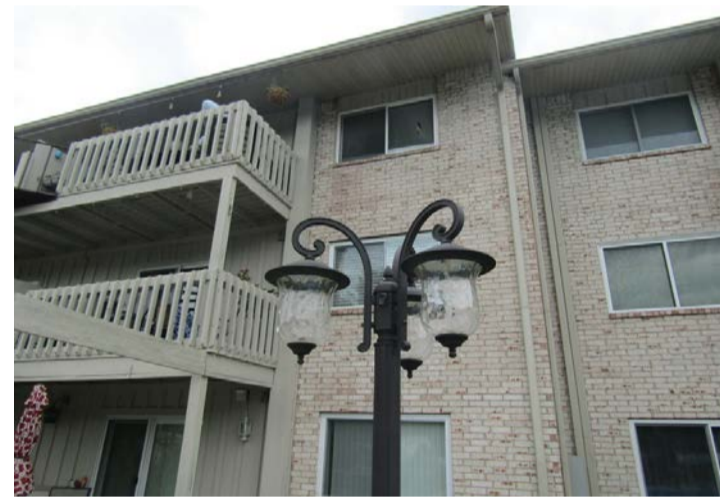
metal light pole with metal light fixture

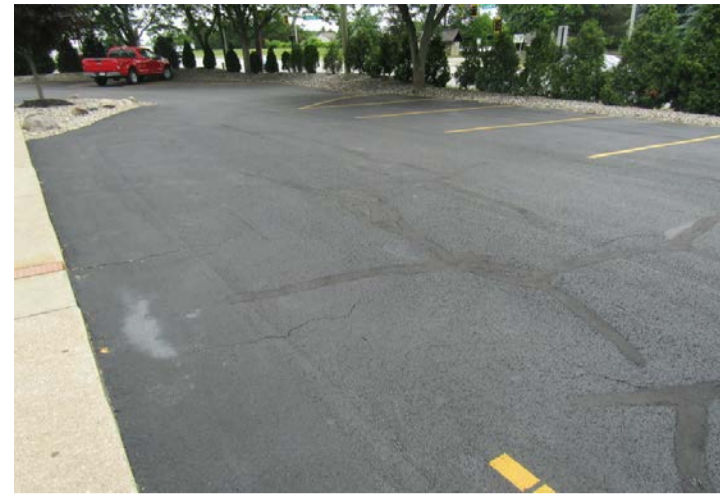
Green ideas: The property has seal coated the asphalt pavement in the past. It is our professional opinion that seal coating asphalt pavement does not extend the useful life of the pavement. Seal coats do not add structural strength to the pavement. Seal coating is also a source of environmental contamination. Many properties opt to save money by *not* seal coating their pavement. If the property decides to seal coat for aesthetic reasons, avoid the use of coal tar based pavement seal coats as they pollute waterways. Instead, consider a slurry coat of asphaltic emulsion to provide a sacrificial wearing surface to the pavement. Also, if the property chooses to seal coat, we recommend applying the seal coat in the spring rather than the fall. Snow removal equipment wears the seal coat. Application in the spring will provide the maximum visual enjoyment from a fresh seal coat.

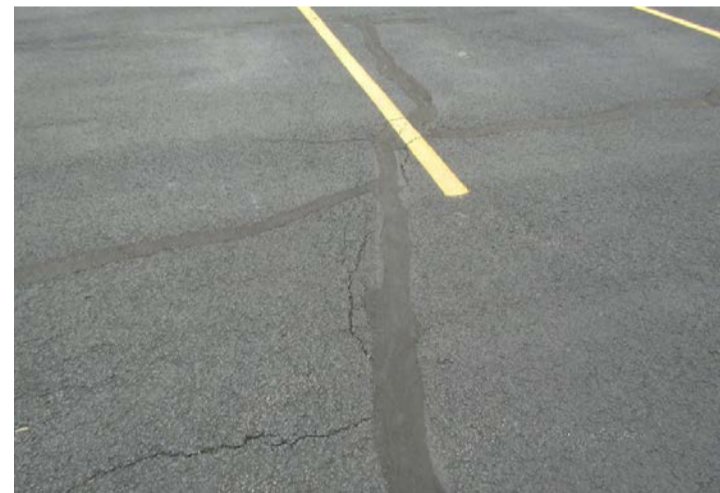
repaired and unrepaired cracks
