ENGINEERING & CONSULTING

888-688-4560

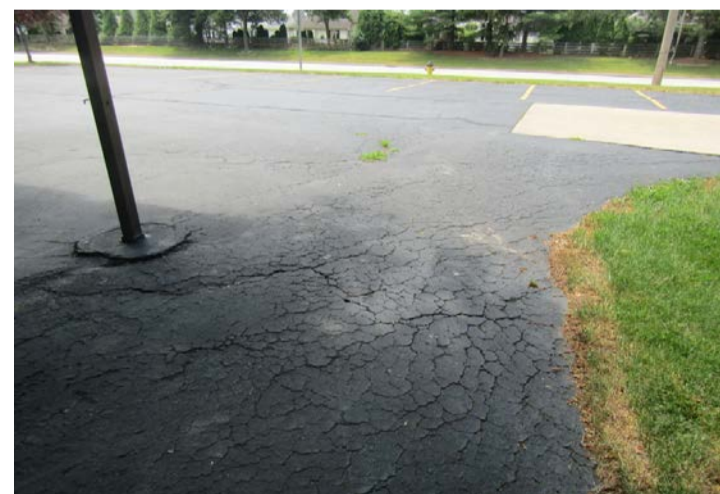
repaired and unrepaired cracks

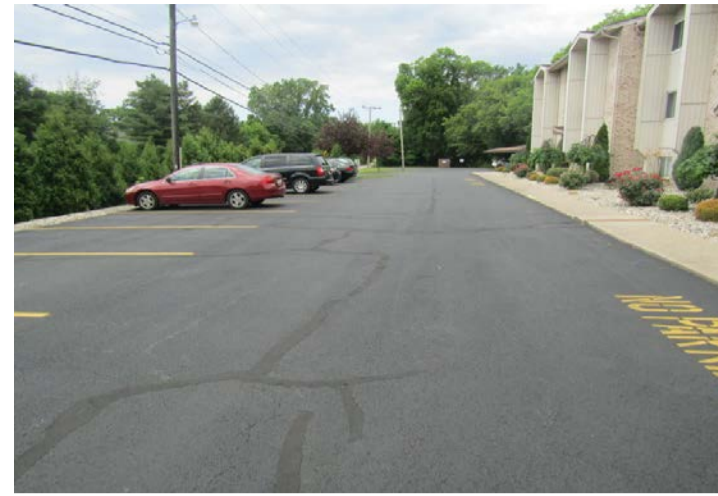
asphalt pavement at parking areas

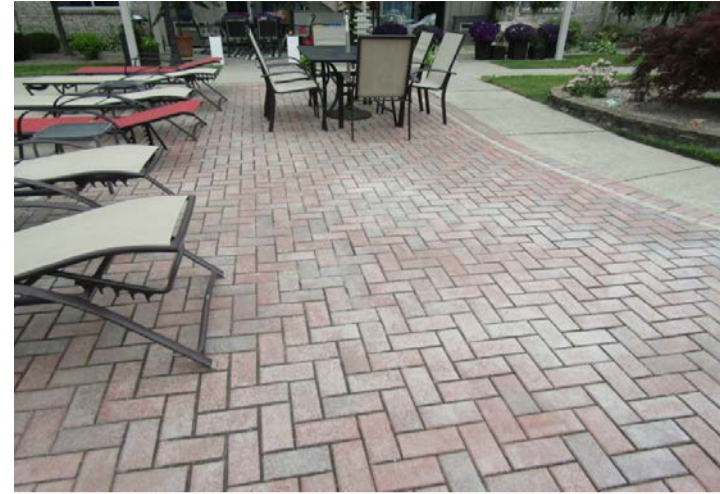
herringbone pattern dry set masonry pavers

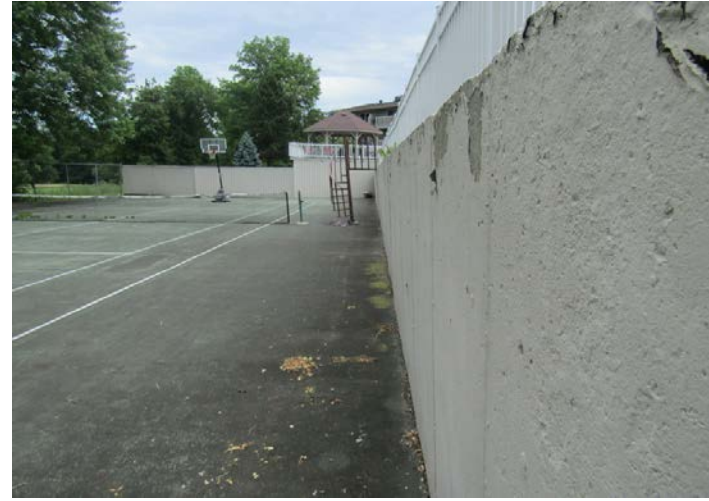
- removal of the fence, landscape and staircase
- excavation behind the wall to a depth that will allow the wall to be straightened
- straighten and repair the wall
- install drainage system behind the wall
- backfill with non-compressing fill
- reinstall the fence, landscape and staircase

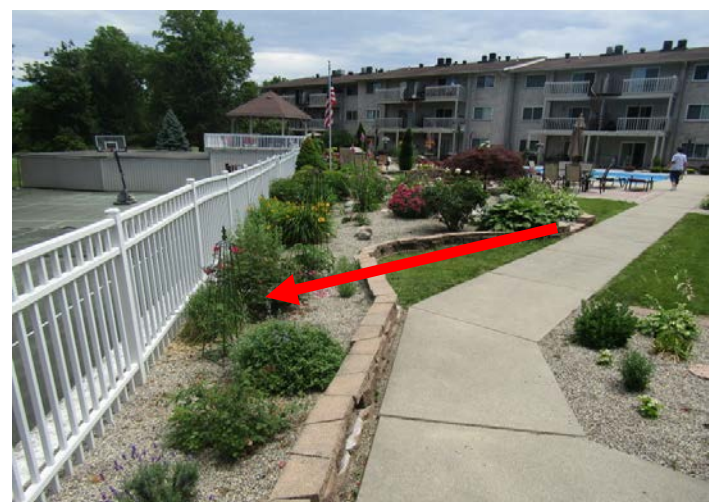
grade pitched towards wall

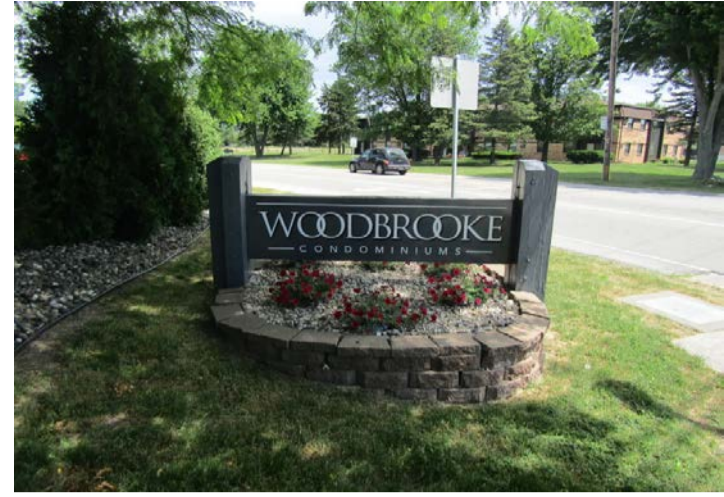
Material: wood and composite
Overall condition: good to fair
Specific condition: weathered wood
Current total cost: **\$2,900**
Cost per home: \$73
Operating expenses: painting

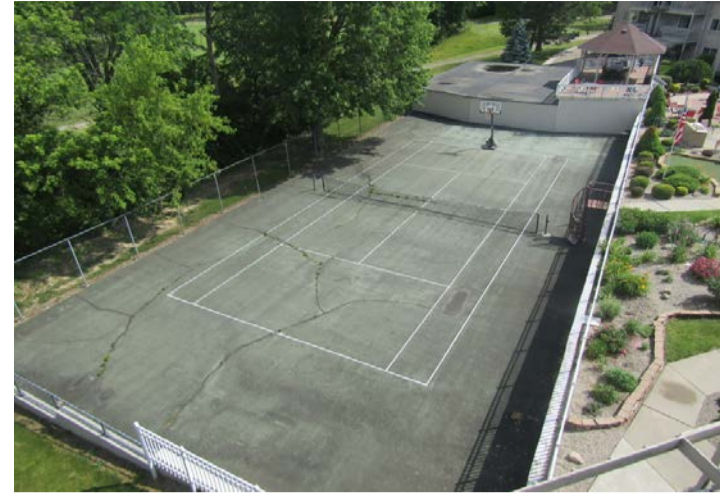
Number of courts (each):	1
Surface material:	asphalt
Play area (square yards):	800
Fence material:	chain link
Fence length (linear feet):	180
Overall condition:	poor
Specific condition:	cracks and poor drainage
Color coat cost:	\$6,900
Fence cost:	\$7,900
Surface cost:	\$31,500
Combined cost:	\$46,300
Combined cost per home:	\$1,158
Operating expenses:	nets

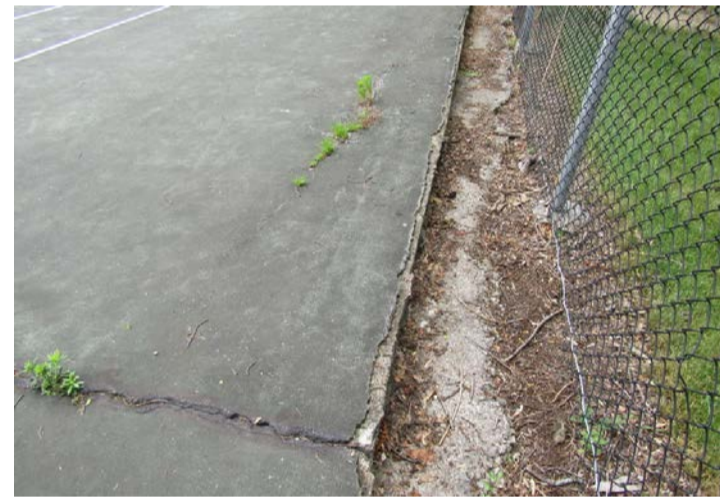
asphalt atop concrete slab

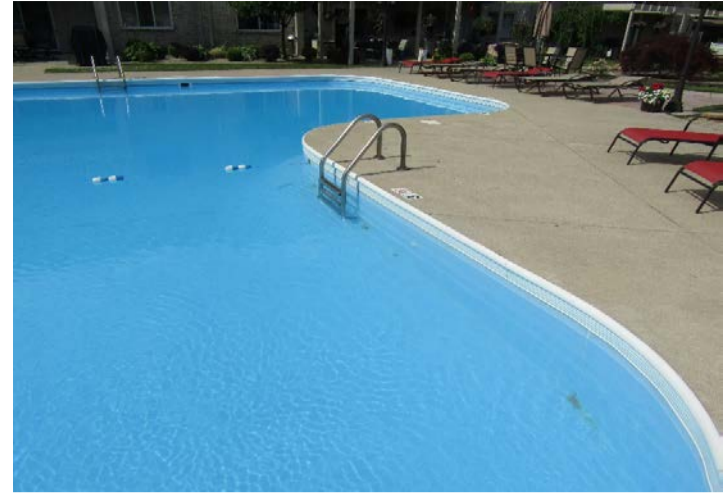
Finish type:	vinyl
Horizontal surface area (square feet):	1,200
Pool capacity (gallons):	48,000
Minimum pool depth (feet):	3 feet 0 inches (complies with industry standard)
Surface water removal type:	skimmers
Overall condition:	good to fair
Specific condition:	peeling paint, warped vinyl, cracks in deck concrete and leak repairs in process
Cost (\$/square foot):	\$15
Current total cost:	\$17,800
Cost per home:	\$445
Operating expenses:	interim painting if desired
Anticipated expenses:	removal of the existing finish install new vinyl light replacement skimmer repairs deck repairs

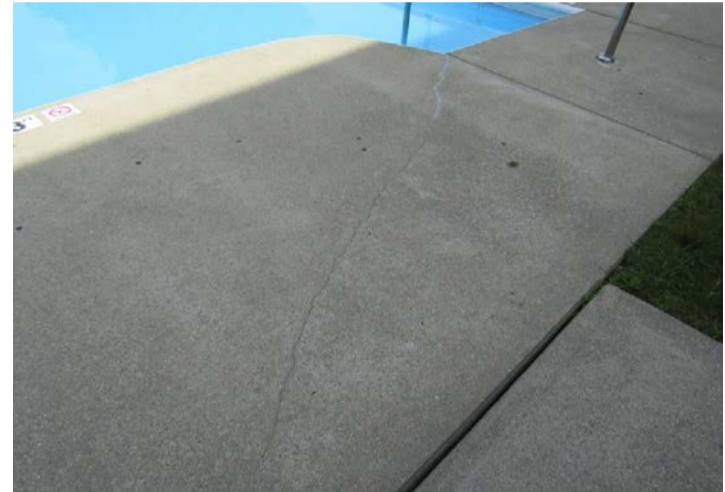
minor crack in deck concrete

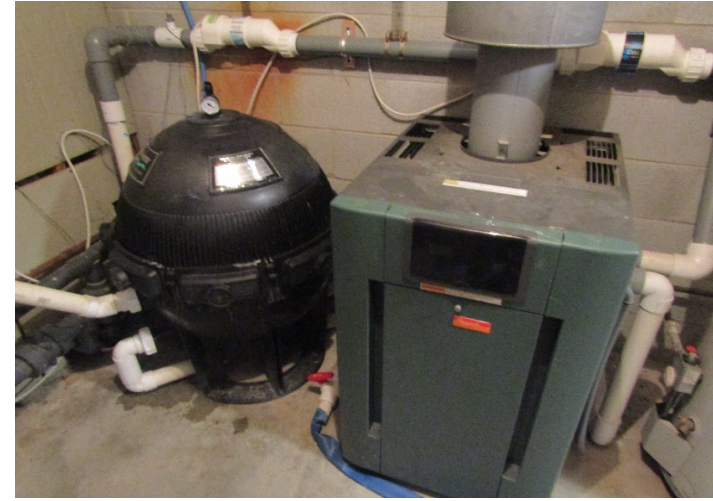
Engineering solutions: Periodic backwashing of the pool filter is necessary to flush accumulated filtered material. Although necessary, this process is wasteful as it discharges the chemically treated and heated pool water. To ensure only the proper amount of water is flushed, a sight glass is critical at the filter to visually monitor the condition of the water being flushed. Backwashing is stopped once the water is clear. A sight glass is not present at the filter. We assume the filter is backwashed for a timed interval rather than based on the visual condition of the water. This could result in either inadequate or excessive backwashing. We recommend the installation of a sight glass to observe the condition of the water being backwashed.
